Cultural Resource Re-evaluation Form

1. Resource Number: 5JA783 2. Temp. Resource Number: _____

5. Resource Name: Case Ranch

Describe Early 20th century ranch complex located in North Park

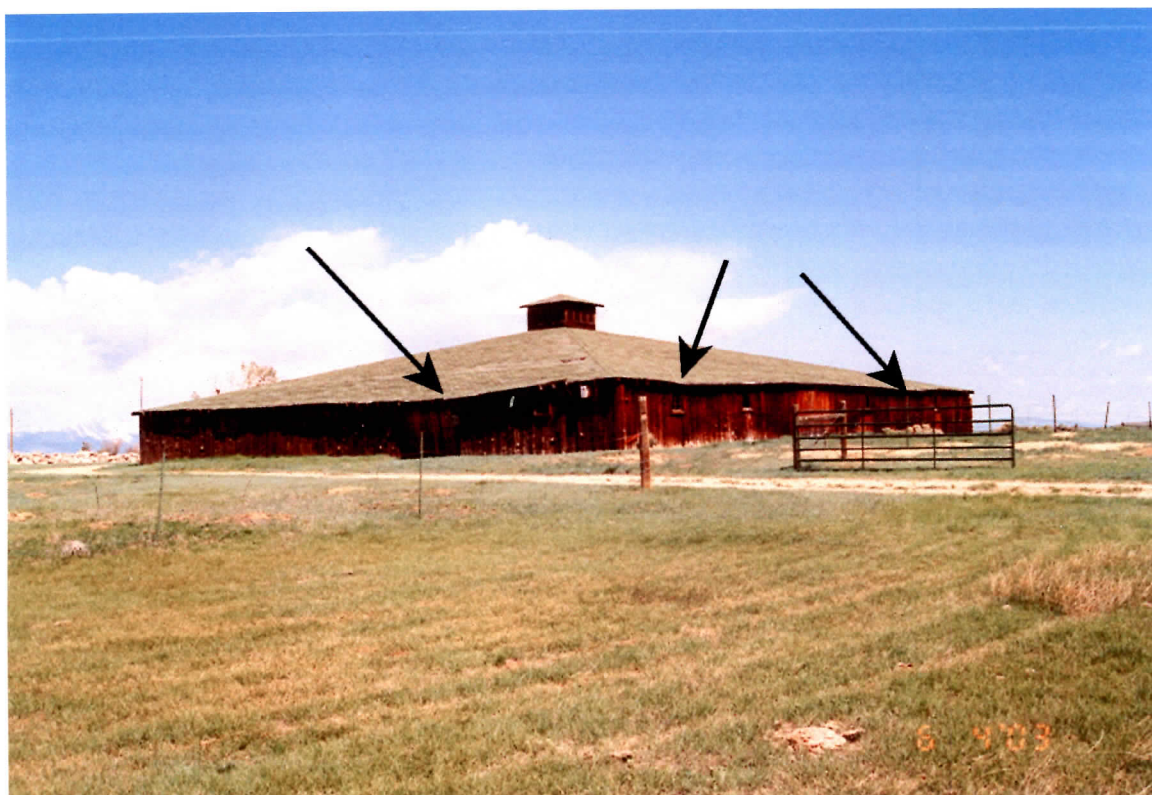
Figure 2: South and east walls of the case barn. Note the sagging roof sections.

14. Management Recommendations: An architectural assessment of the barn needs to be completed. The deteriorating parts of the barn should be rehabilitated and the structure should be interpreted.

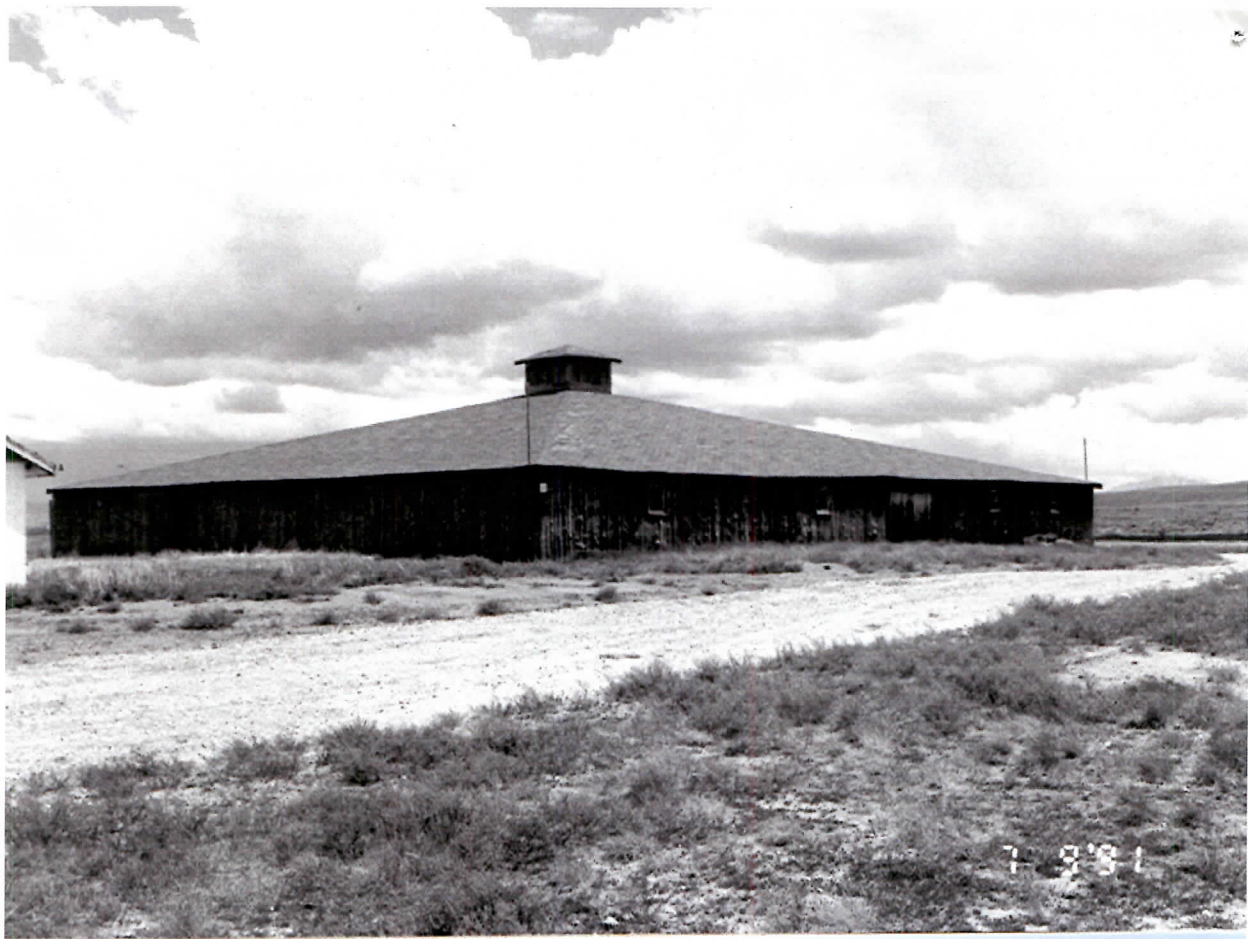
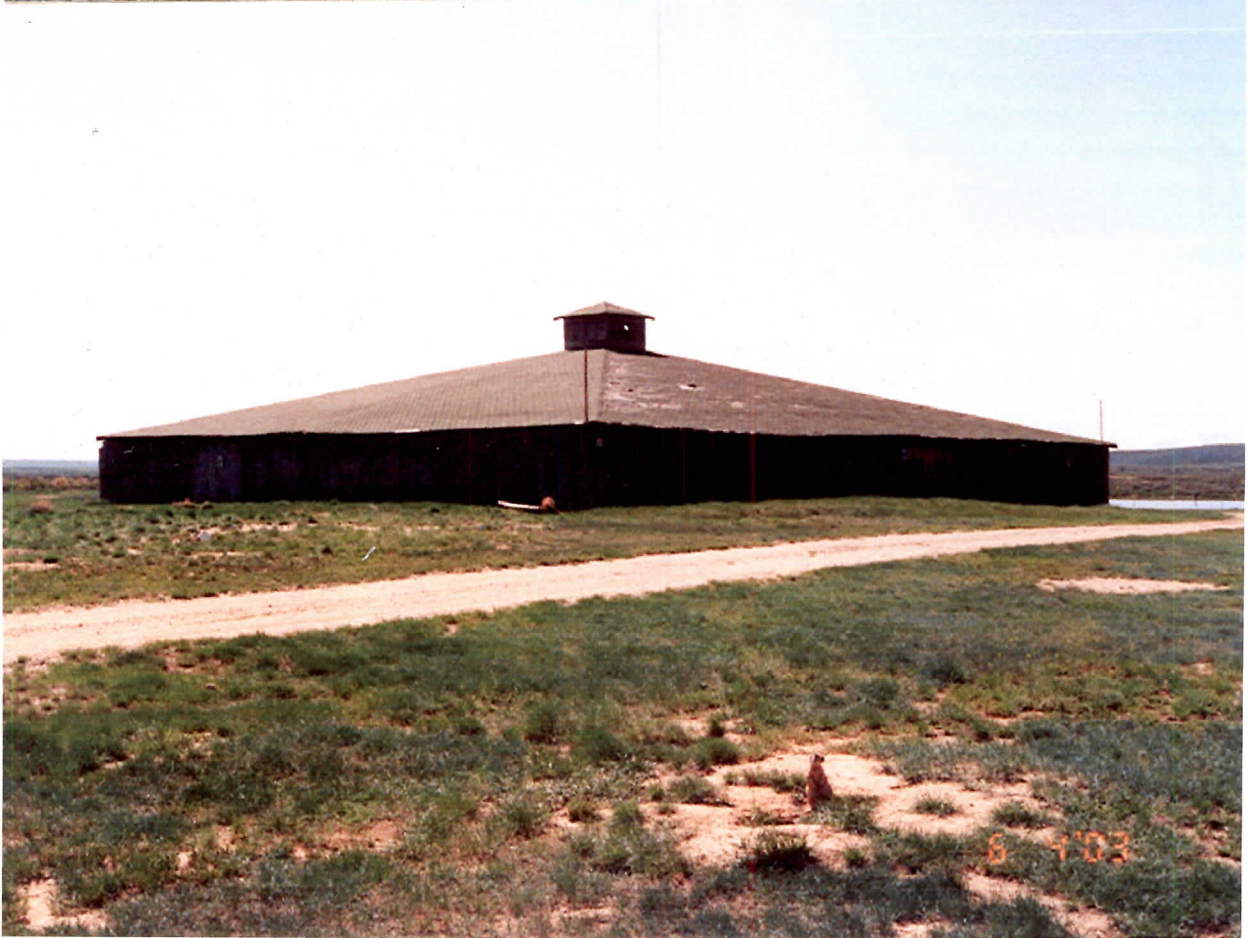
Figure 3: 1991 and 2003 photos of the north and west walls of the Case barn. Note the deterioration of the roofing material near the northwest corner.
